# Module Corroded Area vs. TCO Hardness

Improved Photovoltaic Device And Module  
R. Romero, David E. Carlson, Frank S. Willing  
David H. Meakin  
Case No. SL1217  
Sheet 1 of 1

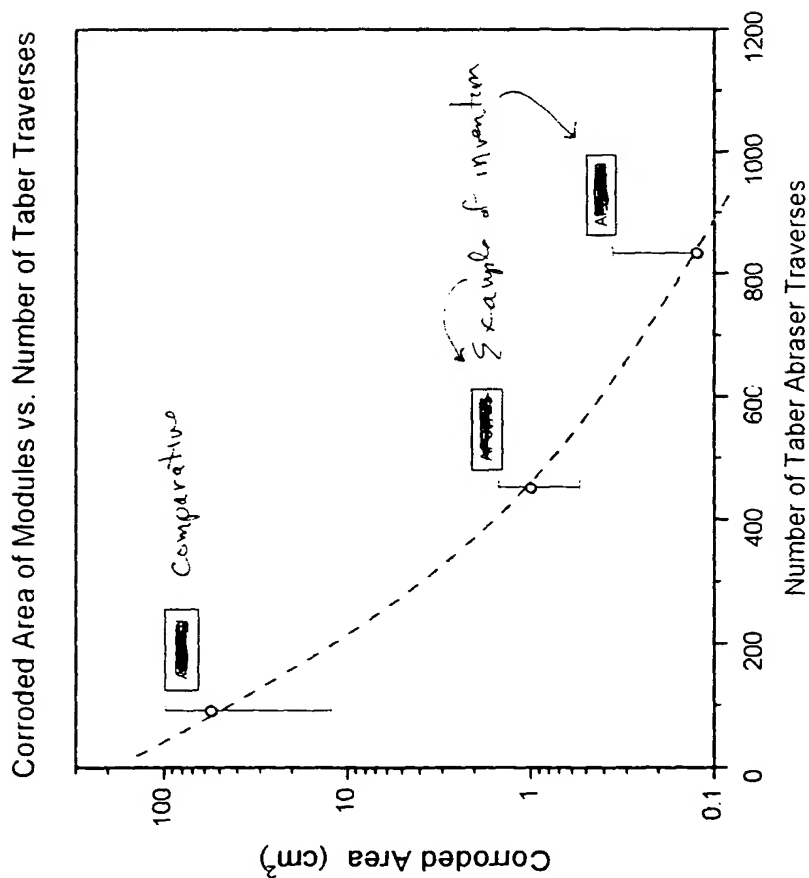
● After 125 hour at 85°C, 85% RH and 70 V forward bias, the corroded area of TF1 modules decreased rapidly with increasing hardness of the tin oxide as measured by the Taber Abraser test.
